SUSCEPTIBILITY OF IRON-BASED ALLOYS TO LOCALIZED (PITTING) CORROSION**Voxidova Durдона Abduqaxxorovna**

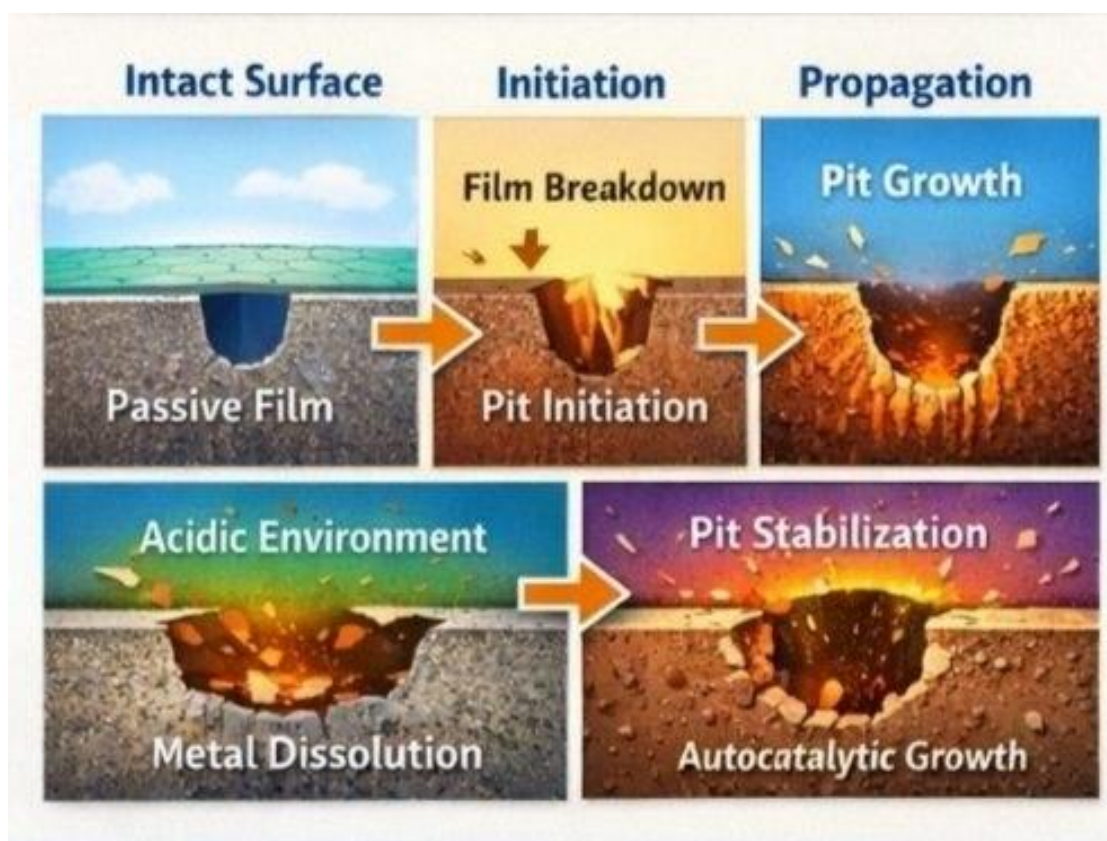
Pitting corrosion occurs in three main stages:

1. Initiation:

- Breakdown of passive film
- Localized dissolution begins

2. Propagation:

- Formation of anodic pit region
- Acidification inside pit

3. Stabilization.

- Pit grows autocatalytically

Figure 1. Schematic of pitting corrosion mechanism.

Pitting corrosion growth mechanism. Once a pit initiates on a metal surface, it develops into a localized electrochemical cell that can sustain itself independently of the surrounding environment. Within the pit, the anodic reaction occurs, where metal atoms lose electrons and dissolve into the electrolyte, producing metal ions. This dissolution process is highly localized, meaning that the corrosion is concentrated in a very small area rather than being spread uniformly across the metal surface. On the surface surrounding the pit, the cathodic reaction takes place, usually involving the reduction of oxygen or hydrogen ions present in the solution.

The separation of anodic and cathodic regions creates an internal electrochemical gradient that further drives the corrosion process within the pit.

As the pit deepens, the environment inside it changes significantly. The concentration of metal cations increases, and chloride or other aggressive ions from the solution accumulate, leading to a significant drop in local pH. This local acidity accelerates the dissolution of the metal inside the pit, creating a feedback loop where deeper pits promote even faster corrosion. The pit essentially becomes self-sustaining because the electrochemical reactions inside continue independently, while the surrounding metal surface remains relatively passive. Over time, this mechanism can result in rapid penetration of the metal, potentially causing structural failure even if the total metal loss appears minimal. Understanding this pit growth mechanism is crucial for designing corrosion-resistant alloys and applying protective coatings that can prevent initiation and propagation of localized corrosion [9].
